**Sand mining and its impact on the river health: A case study of Kynshi River,
Meghalaya**

Mr Preciouswell Nongsiej

North Eastern Hill University, Shillong

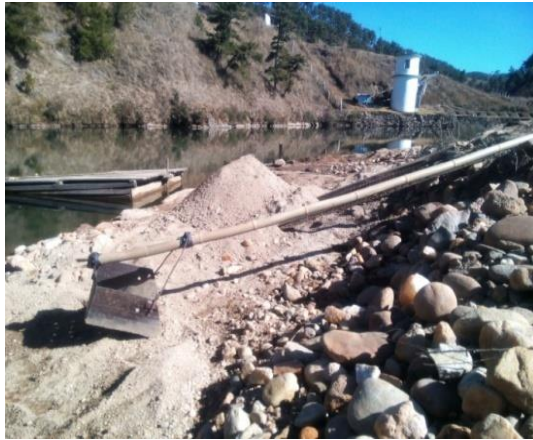
Plate 1: bar skimming method

(ii). Bar skimming, on the other hand, is the controlled extraction of sand from the exposed sand bars (in stream bars and point bars) in the channel environment. Usually, bar skimming would be done above the water table and within a minimum width buffer that separates the excavation site from the low flow channel and the adjacent active channel bank. Shovel was used to extract the sand and carry it in a basket from the bank of the river to the road side for easy transport

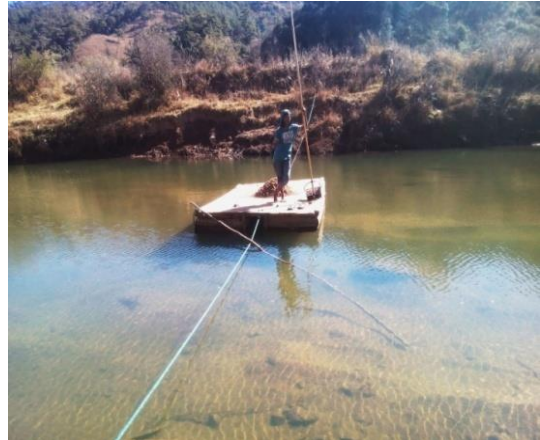
Plate 2: Showing wet pit mining.

(i). Pit excavation is extraction of sand and gravel from the riverbed or floodplain areas by uncontrolled digging, in which draglines or dredges remove material from below the water table or directly from a stream channel. A long shovel which has a curved tin tie with a long wooden stick for easy extraction of the sand from the river bed has been used.

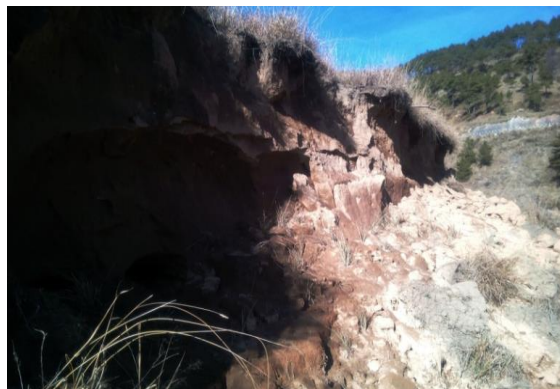
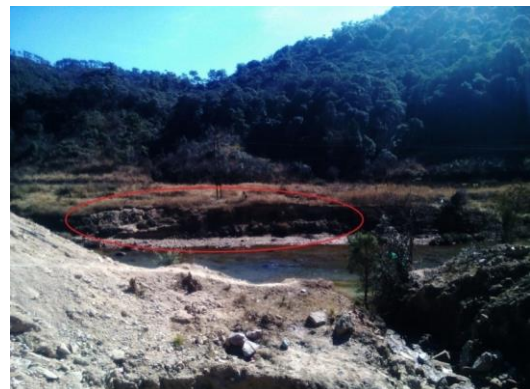
Erosion on the bank of the river kynshi.
